Technical Report GL-94-13
April 1994

Archaeological Geophysics Investigation of the Wright Brothers 1910 Hangar Site: Wright-Patterson Air Force Base, Ohio

Prepared for U.S. Army Construction Engineering
Research Laboratory

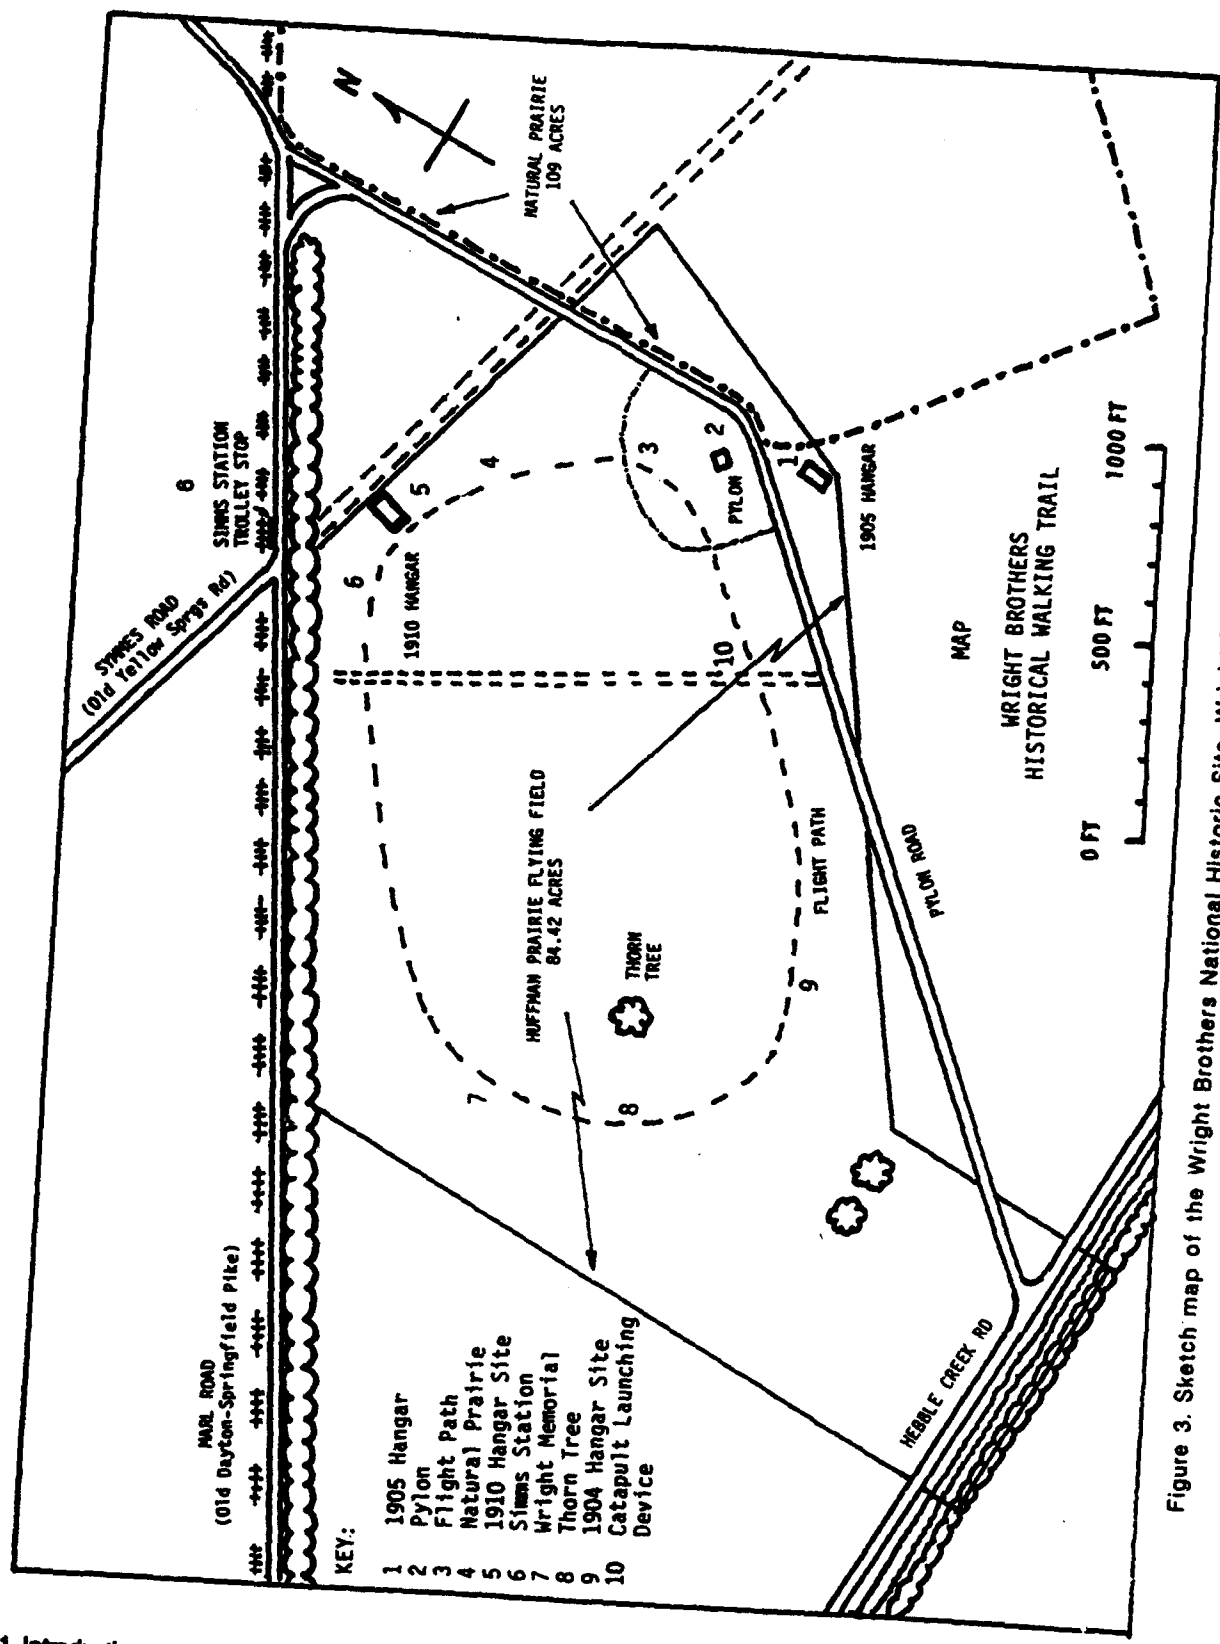
Figure 3. Sketch map of the Wright Brothers National Historic Site, Wright Patterson Air Force Base, Ohio

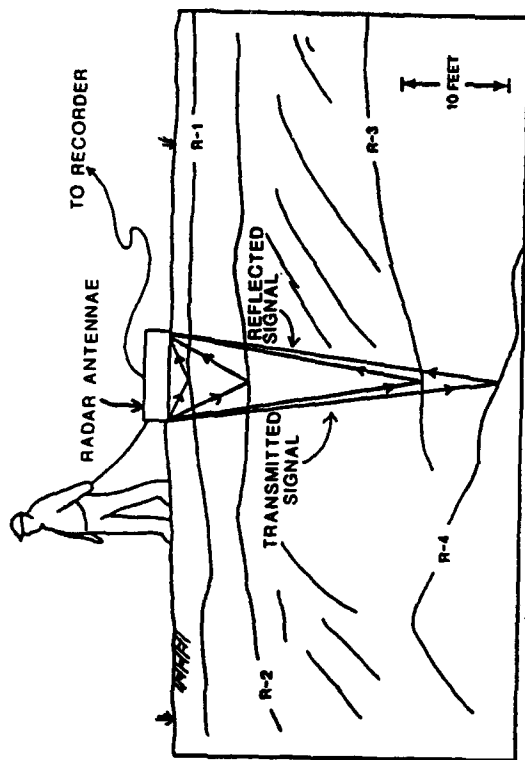
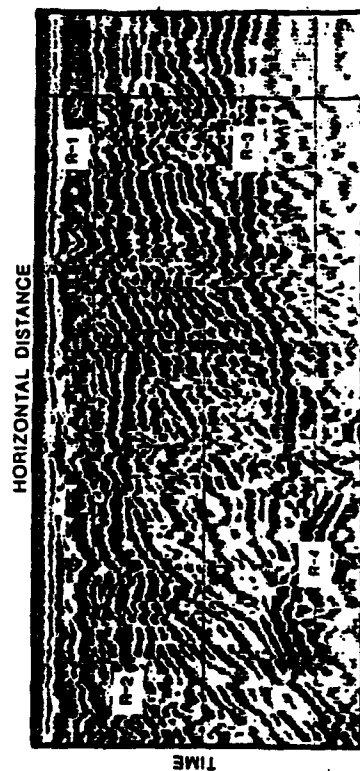
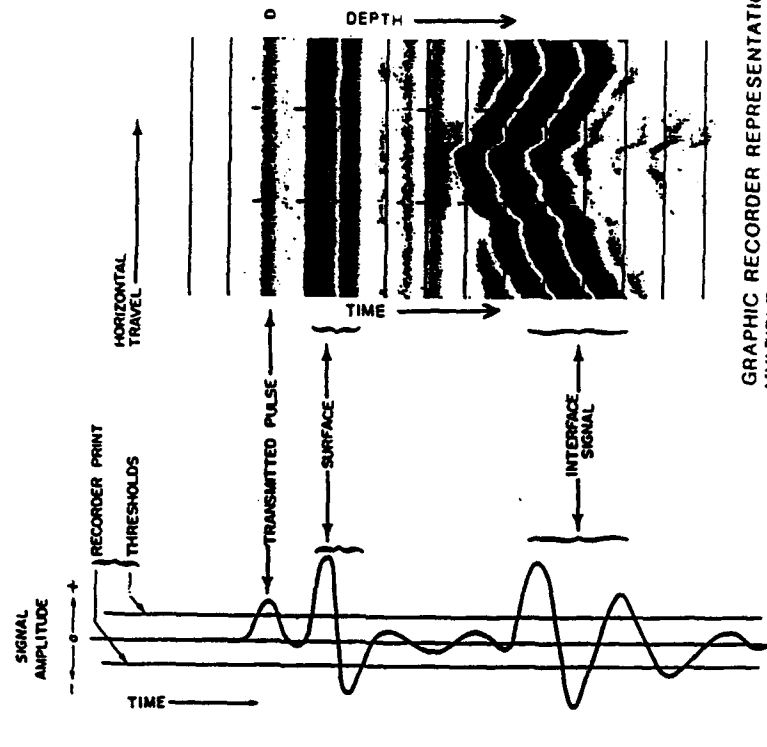
Figure 4. Ground penetrating radar surveying

GPR SURVEY OVER GEOLOGIC SECTION, REFLECTORS R-1 -- R-4

GRAPHIC RADAR RECORD FOR ABOVE SECTION

4a. GPR survey concepts

GPR RECEIVED SIGNAL AND GRAPHIC PROFILE DISPLAY

SKETCH OF TYPICAL SINGLE WAVEFORM

GRAPHIC RECORDER REPRESENTATION OF MULTIPLE WAVEFORMS ALONG A PROFILE

4b. GPR graphic record

GPR is an electromagnetic geophysical method typically utilizing electromagnetic frequencies of 50 MHz to 1 GHz. The method includes a transmitter (Tx) and receiver (Rx) that are pulled or moved on the surface a fixed distance apart along profile lines. The Tx emits a short pulse of electromagnetic energy that propagates into the subsurface, reflects from interfaces between different geologic materials or conditions (such as the water table) and objects or other features within the subsurface, and is then recorded (by a graphic recorder or on magnetic tape or computer disk). GPR antennae are commonly classified by the center frequency of the pulse emitted by the Tx. For the present work, a 300 MHz antenna was used. Figure 4a is a cartoon illustrating a GPR survey over some subsurface reflectors and the resulting graphic GPR record. The graphic record represents amplitude of the electromagnetic signal at the Rx as a function of the horizontal distance (from some starting point on a survey line to the center of the Tx-Rx pair) and the two-way (down and up) travel time of the signal. An illustration of the manner in which the electromagnetic signal (amplitude versus time) is converted into what is shown on the graphic record is given in Figure 4b.

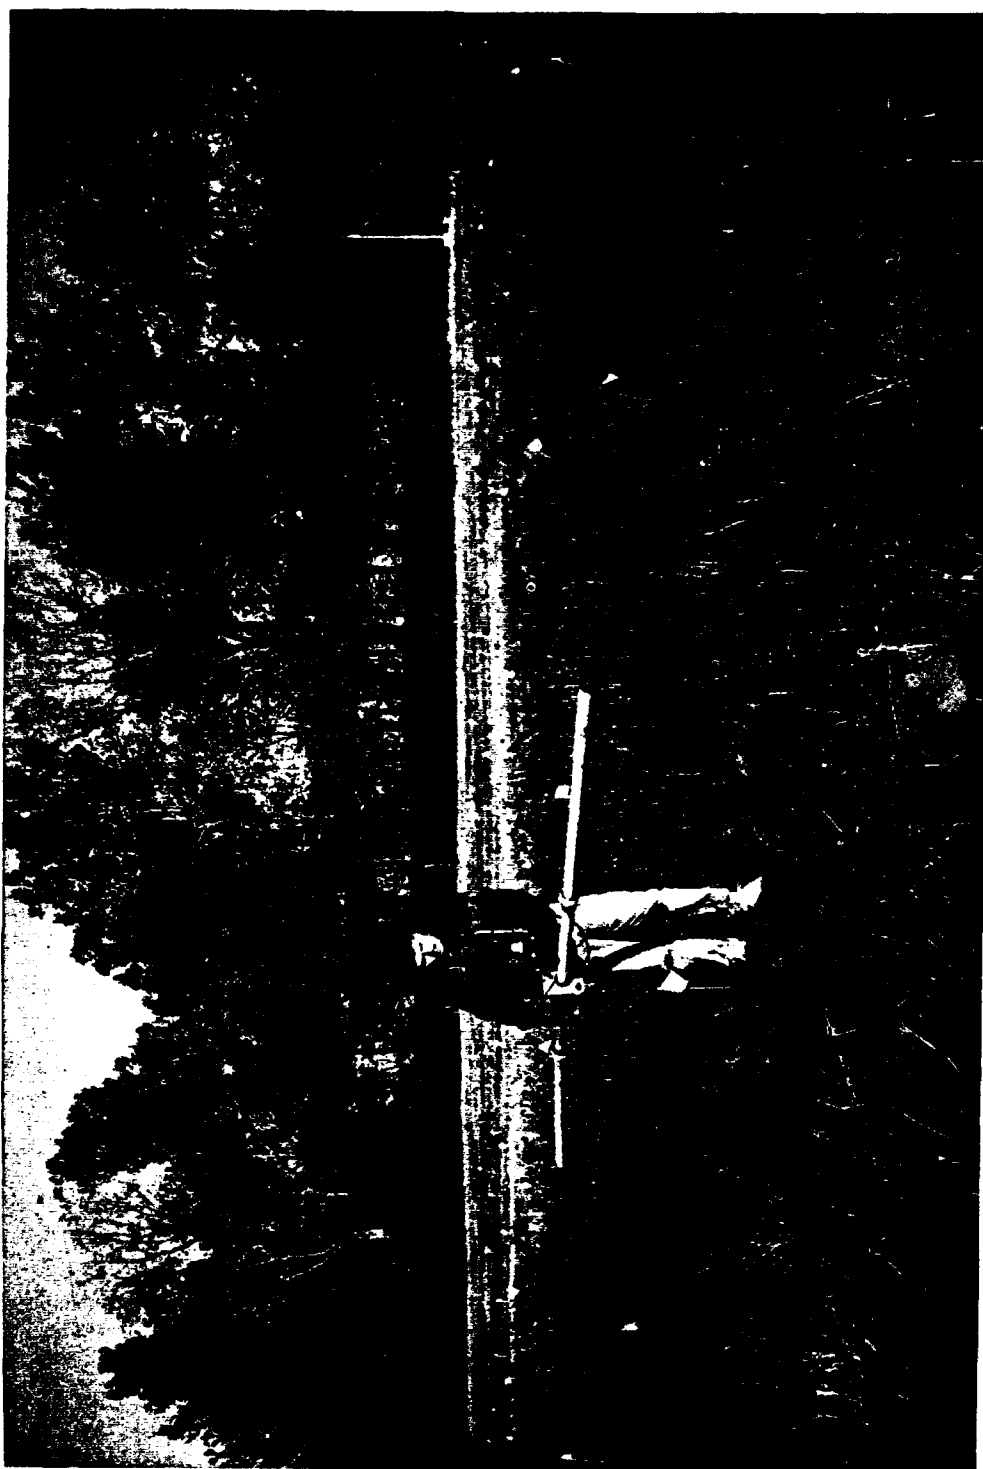
Figure 5. The EM31 during a survey at the hangar site. Flying Field Flag #6 is shown in the background.
The small flags define a 4 x 4 m grid over the 100 x 68 m survey area

Figure 5 shows the EM31 during a survey at the hangar site. The approximate depths of investigation given for these instruments should be used only as "rules of thumb" and are for the horizontal coplanar Tx-Rx coil orientation. The rule of thumb depth of investigation for the EM31 accounts for the fact that the instrument is carried approximately 1 m above the ground.

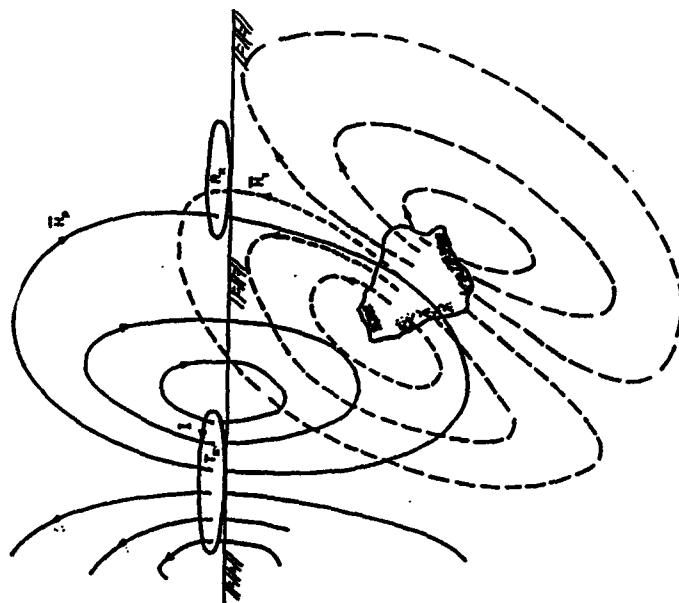
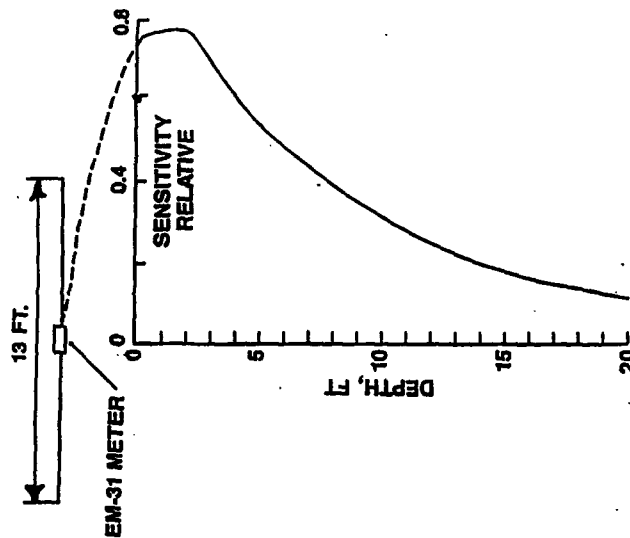
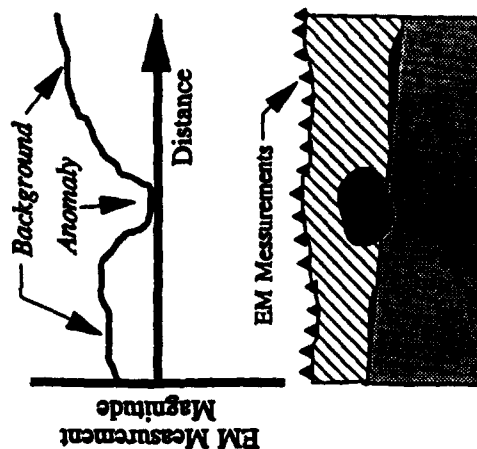
6a. EM induction. Tx--transmitter;
Rx--receiver; I--current; H_p --primary field;
 H_s --secondary or induced field

6b. EM31 response versus depth, for
instrument carried at "hip-height"

6c. Concept of EM anomaly and
background for a hypothetical
geologic section

The Tx generates a time-varying magnetic field (the primary field) that interacts with subsurface materials to induce electrical currents and secondary magnetic fields. Secondary magnetic fields from subsurface materials are detected by the Rx along with the primary field. Figure 6a illustrates the concept of operation of the EM instruments. Tx and Rx are shown as horizontal coplanar coils at or near the surface, and the Rx is shown being

influenced by both the primary magnetic field and the secondary magnetic field. The EM instruments can measure both a component in-phase with the primary field and a component 90° out-of-phase (called the quadrature component) with the primary field. The quadrature component is directly proportional to the electrical conductivity of the subsurface feature and is expressed in mS/m (milliSiemen/meter), while the in-phase component is expressed in ppt (parts per thousand) of the primary field. Conductivity measured by the EM instruments is properly termed an apparent conductivity and represents a weighted volume average of true conductivity of materials within the volume of investigation of the instruments; Figure 6b illustrates the depth weighting (relative sensitivity) for the EM31. The in-phase component is primarily used for detection of subsurface metallic objects. Magnitude and spatial width of the secondary field detected by the Rx depends on the electrical conductivity of the subsurface anomalous feature as well as its size and depth. When the Tx and Rx are moved together along a surface profile over a subsurface anomalous feature, an anomaly will be detected (1) if the subsurface feature is within the depth of investigation of the instrument and (2) if the feature is sufficiently large relative to the spacing between surface measurement points; the anomaly will be relative to the normal background (Figure 6c). EM data are acquired on profile lines, and then processed to give EM anomaly contour maps.

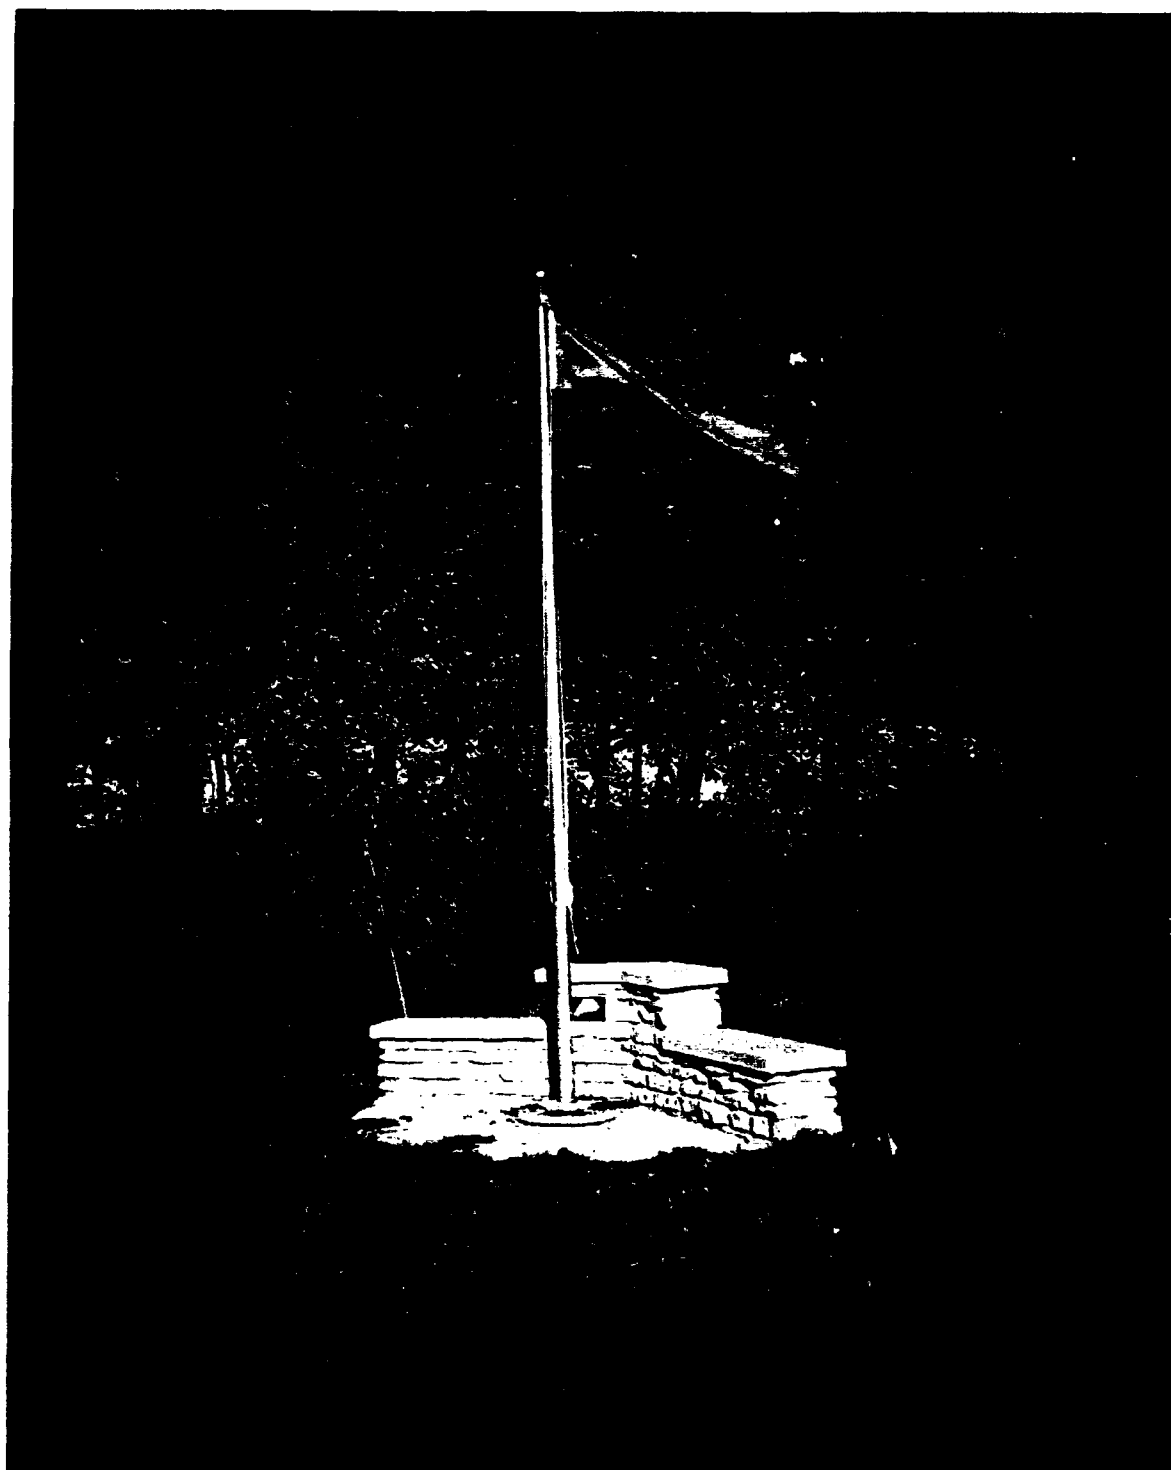
Figure 7. Flying field flag #6; survey grid coordinates (0E,68N)

Semi-permanent features noted on the site map (Figure 8) are the concrete marker, Flag #6 (Figure 7), and walking tour pole markers. All of these features are connected by mowed walking paths, also shown on the map. Transient features noted on the map are ground hog holes. The holes are as large as 30 cm in diameter and many apparently extend well into the glacial gravels beneath the soil (based on considerable amounts of gravel in excavated material). Both semi-permanent and transient features are important for reference and for correlation with locations of geophysical anomalies. For reference completeness, the CERL archaeological excavations of 1990 assign location coordinates (500N,400E--*geographic north and east*) to the location of

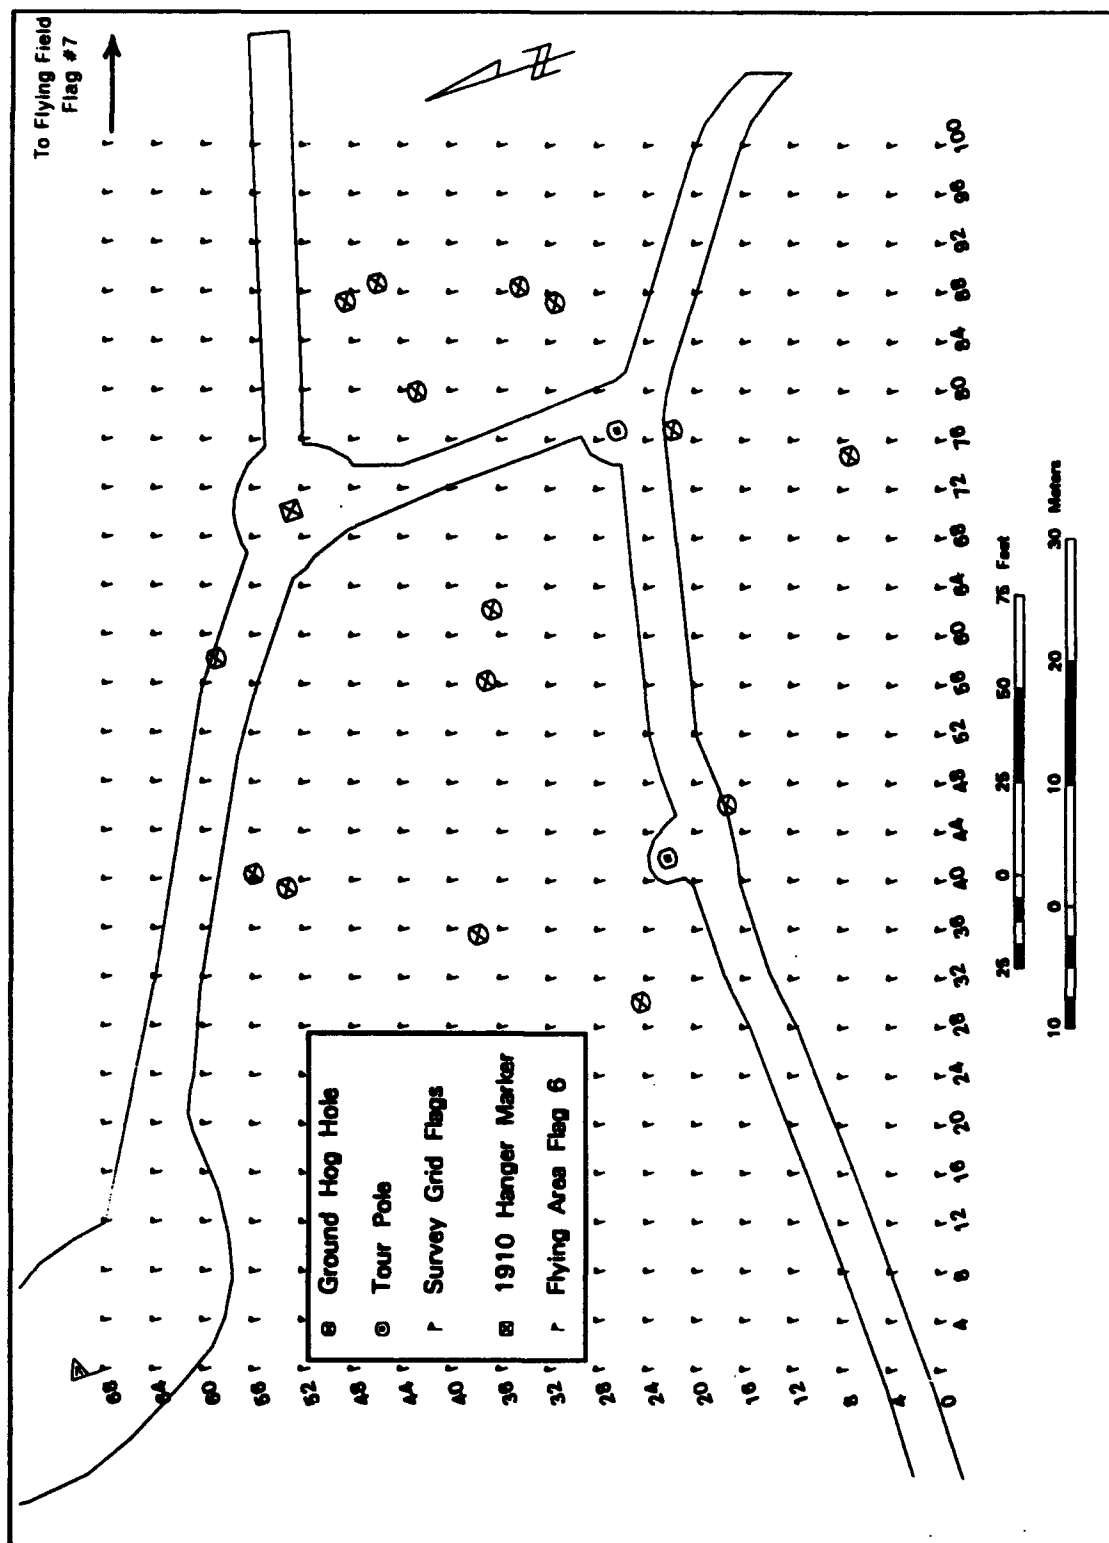
Figure 8. Site survey grid showing semi-permanent and transient features

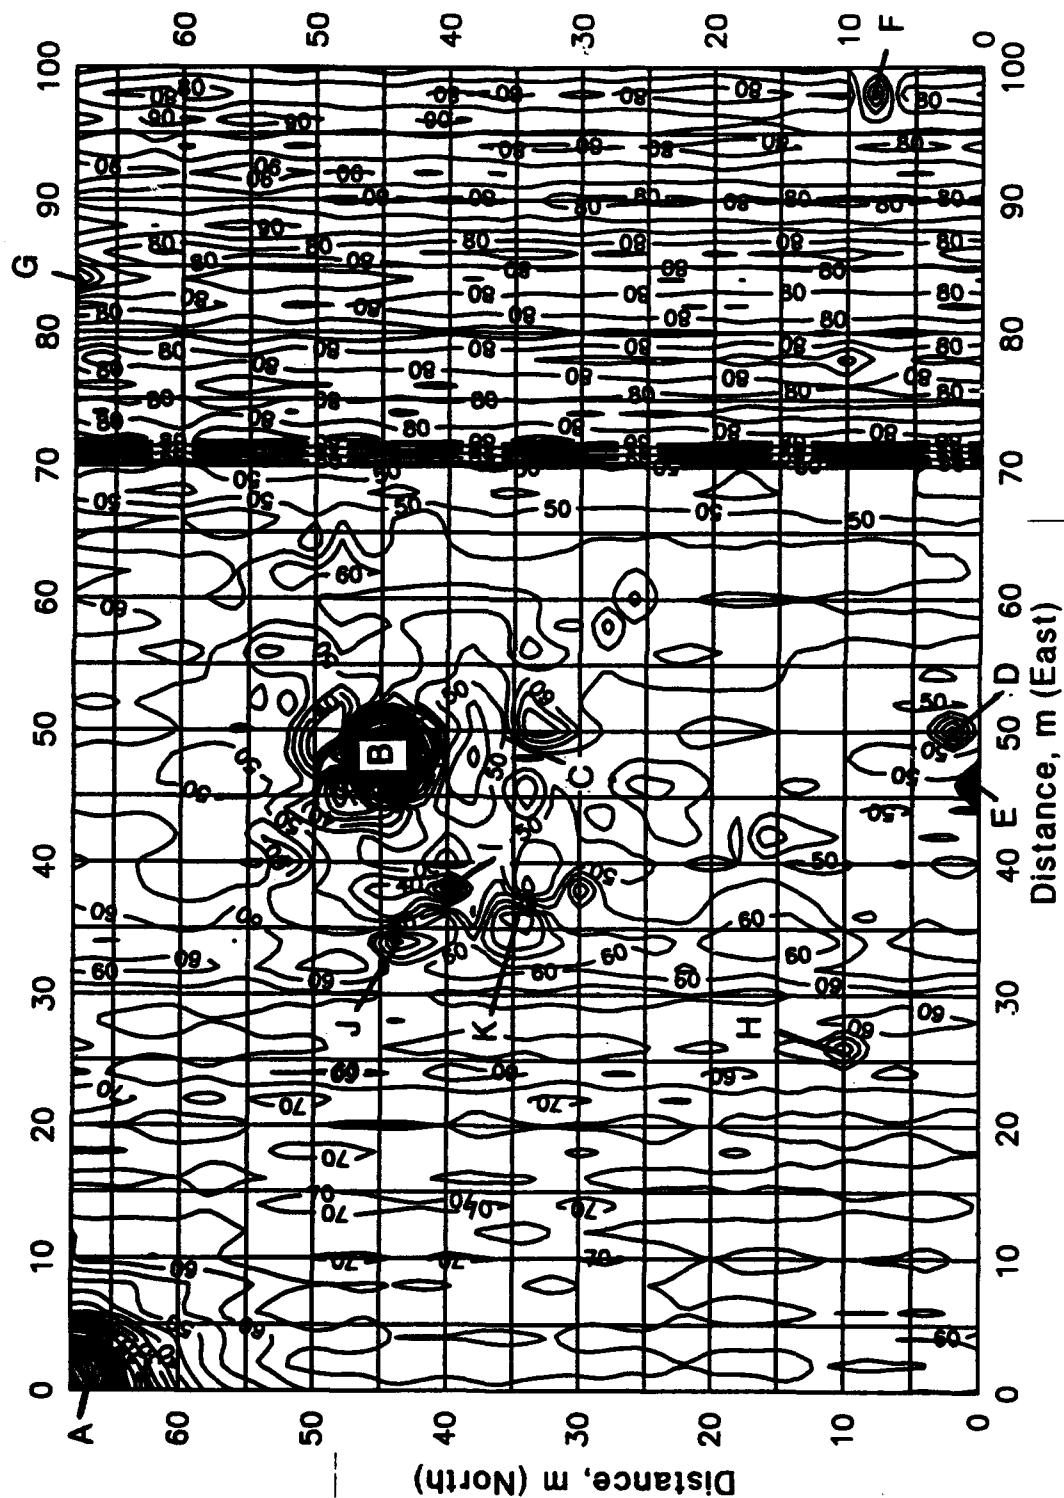
Figure 10. Magnetic total field contour map; 5 nT contour interval

Magnetic anomaly contour maps are shown in Figures 10 and 11. With a contour interval of 5 nT, the contour map in Figure 10 is "visually distressing." The major problem exhibited by the data in Figure 10 is a north-south alignment ("striping") of contours, that is quite pronounced in the right third of the map (70E-100E). The most likely cause for the striping is the performance of the contouring software and not with any condition at the site itself¹. Where true anomalies exist, they are apparent in spite of the striping. Specific anomalies are labeled with symbols A-K on Figure 10. In Figure 11 the contour interval is 30 nT, and the striping is not apparent; locations of anomalies A-G are still apparent in Figure 11. Anomaly A is caused by metal associated with Flying Field Flag 6 (Figure 7, flagpole and reinforced concrete); the remainder of the magnetic anomalies have unknown causes. Anomaly B is particularly significant; the object causing the anomaly is at depth 3.5 m or shallower and located approximately at (47.5E,47N). Table 1 gives grid locations for the magnetic anomalies A-K.

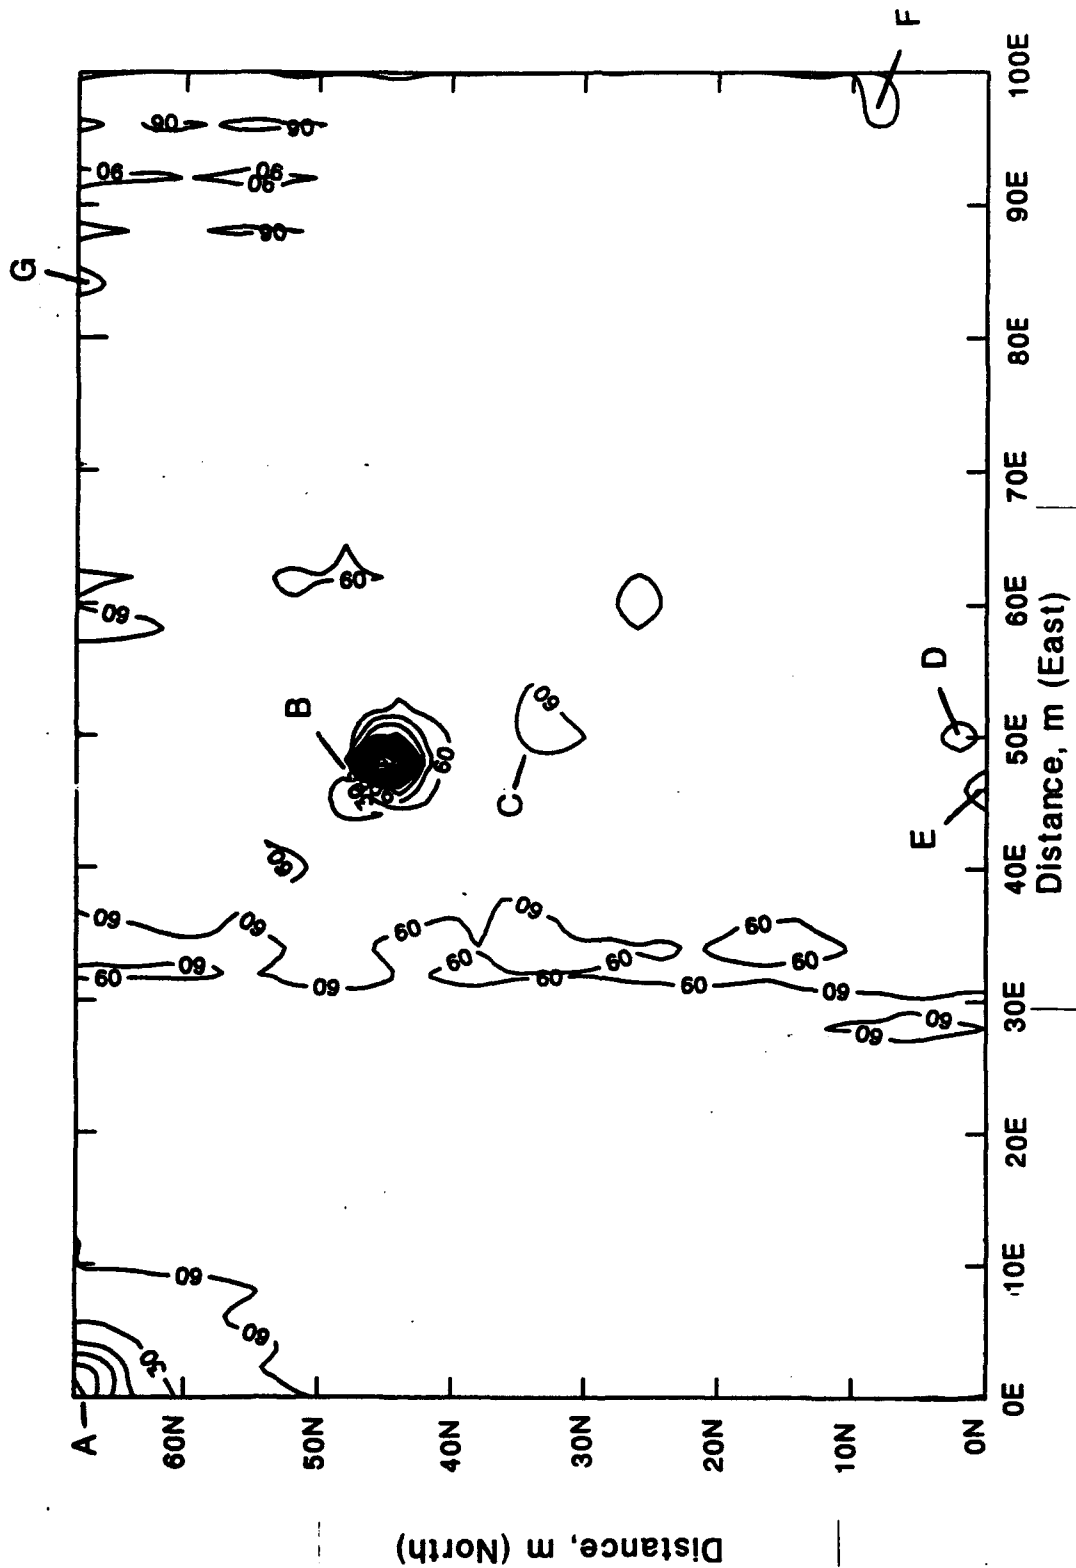
Figure 11. Magnetic total field contour map; 30 nT contour interval

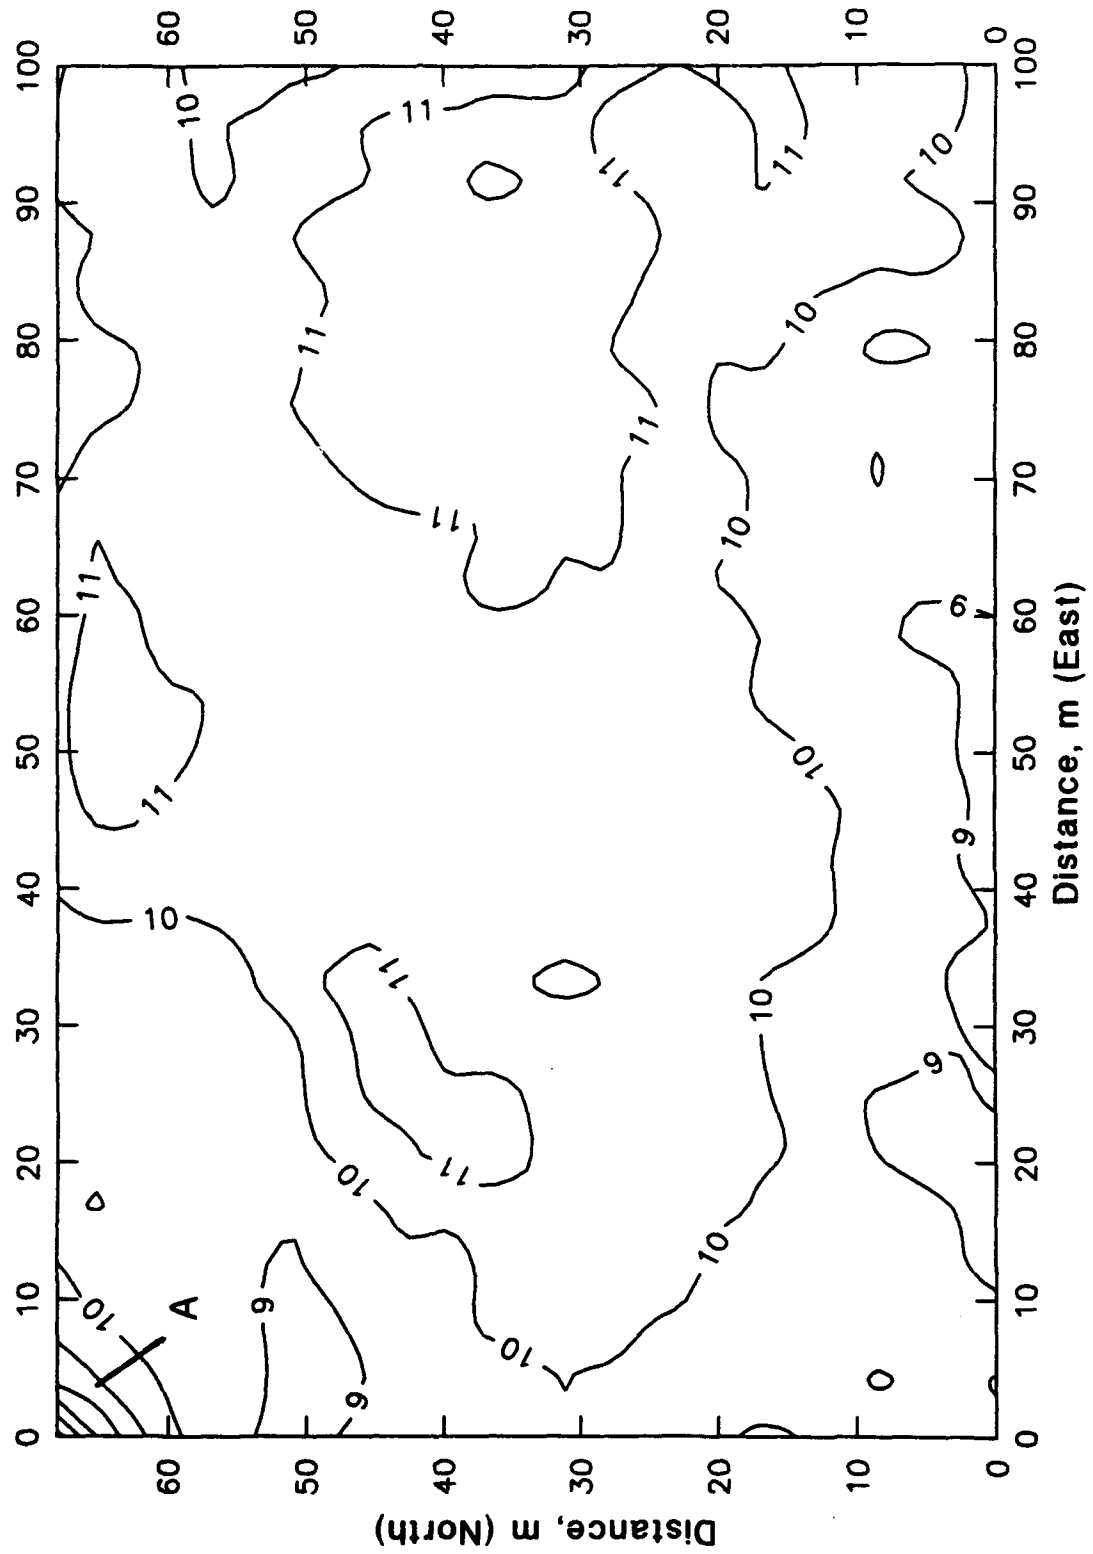
Figure 12. EM31 conductivity contour map; contour interval 1 mS/m

Results of the EM31 electromagnetic survey are shown in Figures 12 and 13. Figure 12 is a contour map of apparent conductivity in mS/m and reveals relatively uniform conditions over the site on a scale of 4-5 m (4 m measurement spacing and 5 m depth of investigation). The apparent conductivity varies slowly spatially from 8-12 mS/m except for anomaly A at (0E,68N), where conductivities as high as 15 mS/m are measured, due to metals associated with Flying Field Flag 6 (Figure 7). Slightly higher conductivities occur in the central and center-right areas of the survey grid, suggesting (1) a slight change in soil composition, (2) an increase in water content, or (3) perhaps an increase in occurrence of small, scattered, conductive cultural artifacts. Three anomalies are labeled on the in-phase contour map in Figure 13: (1) anomaly A is caused by Flying Field Flag 6; (2) anomaly B corresponds in location to magnetic anomaly B; (3) anomaly C corresponds in location to the concrete and bronze monument at (68E,52N).

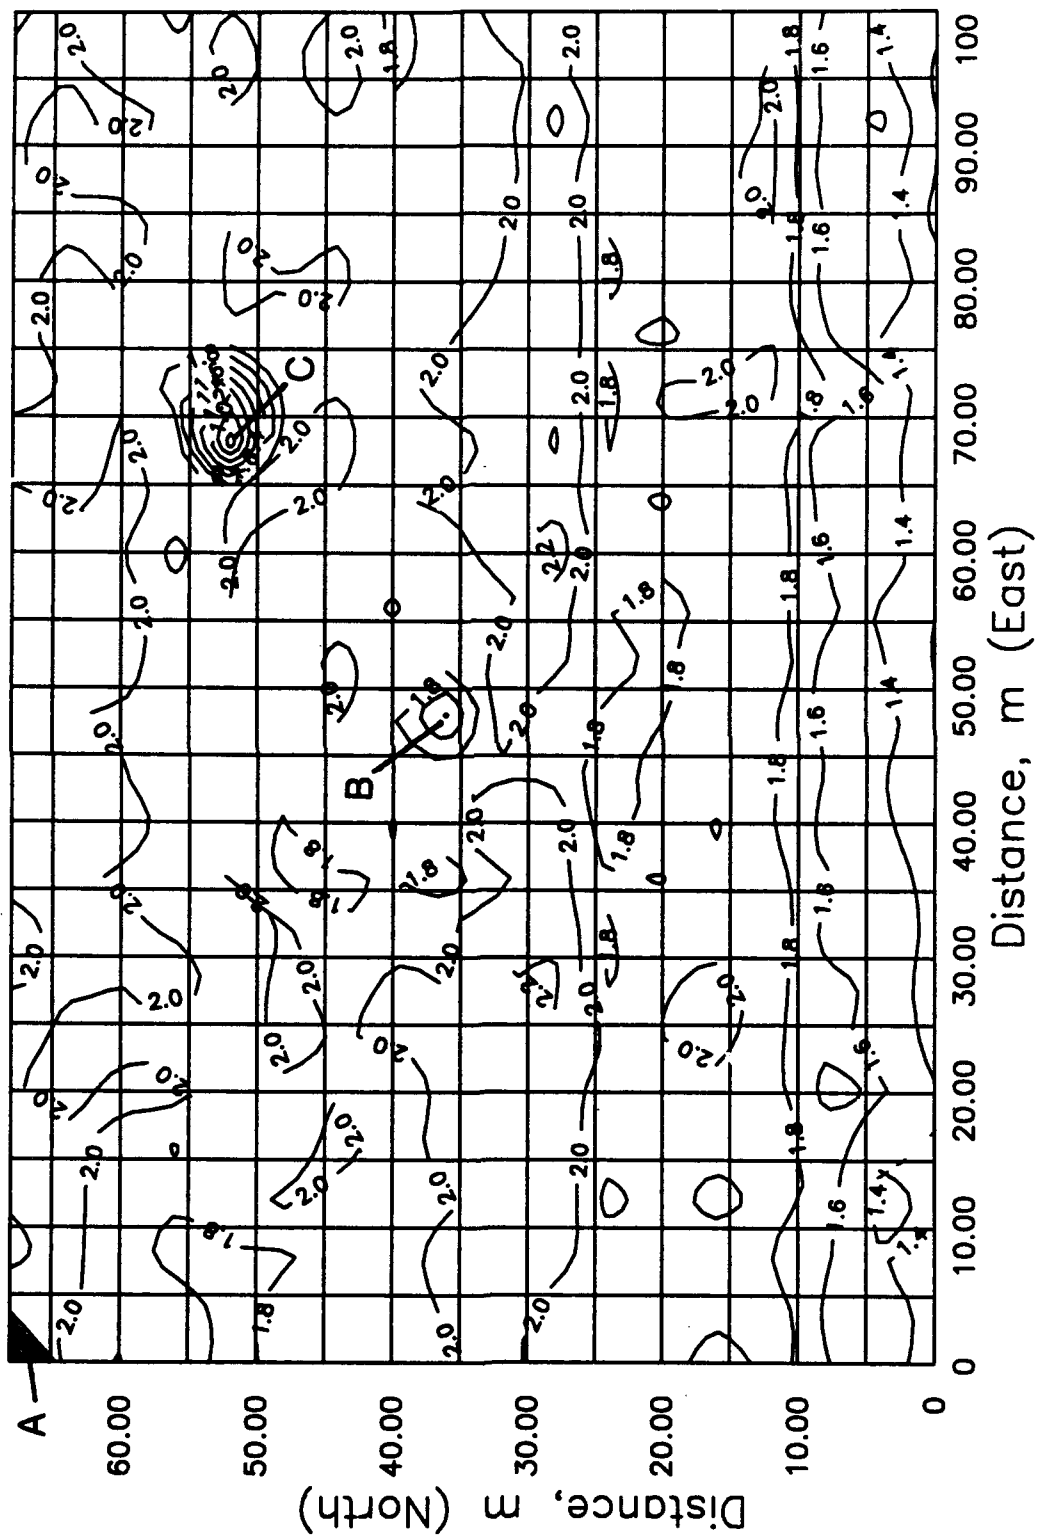
Figure 13. EM31 in-phase contour map; contour interval 0.2 ppt

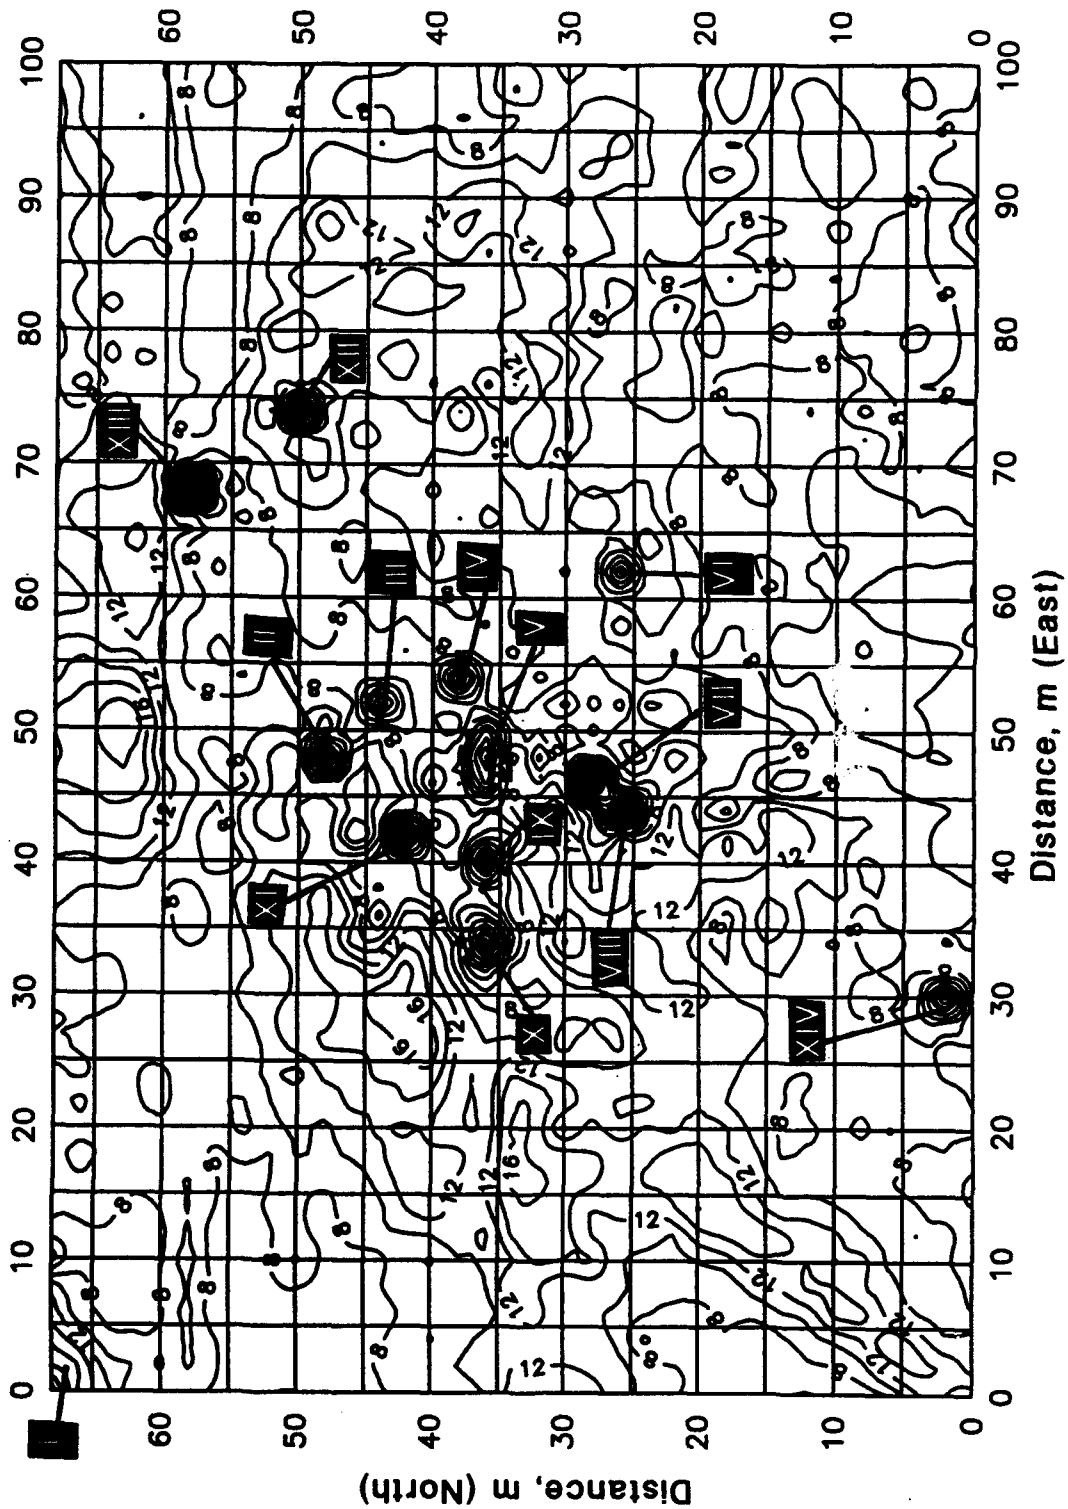
Figure 14. EM38 conductivity contour map; contour interval 2 mS/m

The EM38 survey results are shown in Figure 14, where the contours are apparent conductivity in mS/m over the site on a scale of 1-2 m (2 m measurement spacing and 1.5 m depth of investigation). The map contains many localized anomalies, indicated by labels I-XIV, and general background conductivity varying between 8 and 12 mS/m in agreement with the EM31 results. Table 2 gives location coordinates for the localized anomalies. As indicated in Table 2, only anomaly I is caused by a known feature. Features causing anomalies II-XIV are < 1.5 m deep and very likely < 1 m deep. Nine of the labeled, localized anomalies are in a rectangular area bounded approximately by coordinate lines 25N, 48N, 33E, and 55E; this area is shown in Figure 15. Other localized anomalies with smaller magnitude are not included in Table 2, and several of them are in the rectangular area.

The localized anomalies in Table 2 are low or negative anomalies, which indicates that the likely cause of the anomalies are shallow, buried metallic objects. In addition, there is a significant positive anomaly trend (> 12 mS/m), beginning at approximately 0E,0N and extending to the vicinity of (55E,68N). The positive anomaly trend is shown in Figure 15, where the conductivity contours are for magnitudes ≥ 12 mS/m. Whether this high conductivity trend is due to geologic origins or to some relic of previous site use is unknown. The source of the anomaly is broad, shallow and not continuous along the trend.

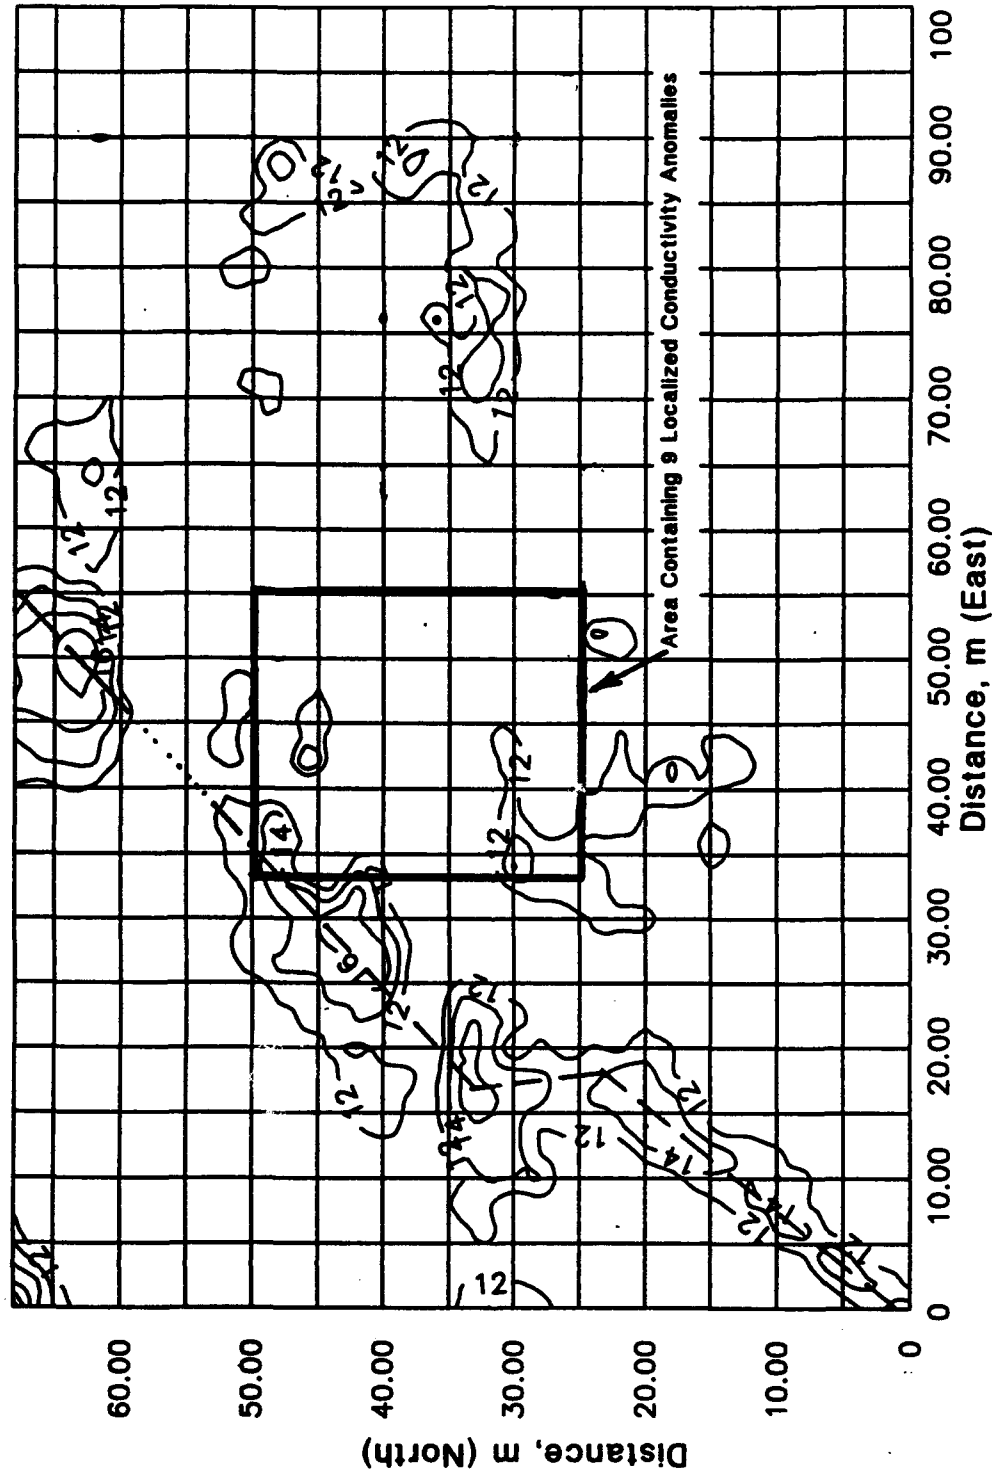
Figure 15. EM38 high conductivity zones (> 12 mS/m) and rectangular area enclosing 9 localized anomalies; contour interval 2 mS/m
